29 Main St, Ellington, CT 06029-3317

MEASUREMENTS

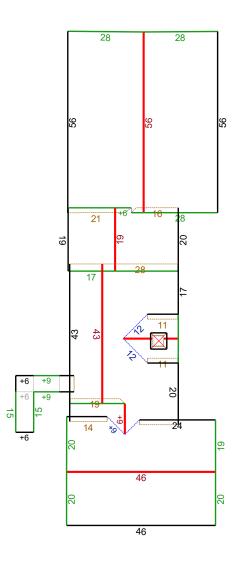
LENGTH DIAGRAM

Total Line Lengths:

Ridges = 188 ft Hips = 22 ft Valleys = 41 ft

Rakes = 319 ft

Eaves = 385 ft

Flashing = 18 ft Step flashing = 163 ft Parapets = 0 ft

Note: This diagram contains segment lengths (rounded to the nearest whole number) over 5.0 Feet. In some cases, segment labels have been removed for readability. Plus signs preface some numbers to avoid confusion when rotated (e.g. +6 and +9).

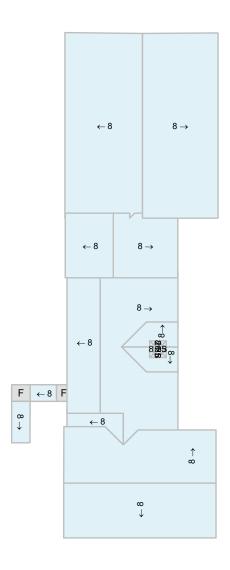
PITCH DIAGRAM

Pitch values are shown in inches per foot, and arrows indicate slope direction. The predominant pitch on this roof is 8/12

Note: This diagram contains labeled pitches for facet areas larger than 20.0 square feet. In some cases, pitch labels have been removed for readability. Blue shading indicates a pitch of 3/12 and greater. Gray shading indicates flat, 1/12 or 2/12 pitches. If present, a value of "F" indicates a flat facet (no pitch).

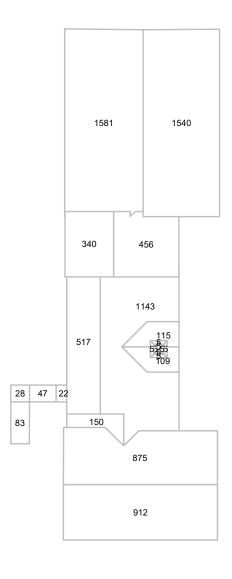
AREA DIAGRAM

Total Area = 7,960 sq ft, with 23 facets.

Note: This diagram shows the square feet of each roof facet (rounded to the nearest Foot). The total area in square feet, at the top of this page, is based on the non-rounded values of each roof facet (rounded to the nearest square foot after being totaled).

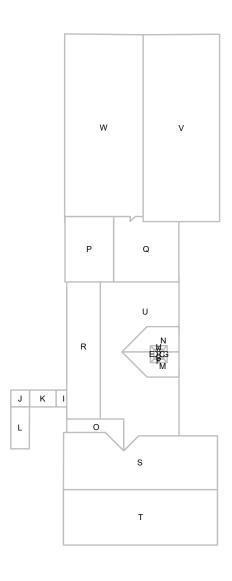
NOTES DIAGRAM

Roof facets are labeled from smallest to largest (A to Z) for easy reference.

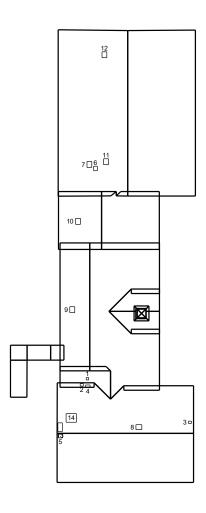
PENETRATIONS NOTES DIAGRAM

Penetrations are labeled from smallest to largest for easy reference.

Total Penetrations = 14
Total Penetrations Perimeter = 101 ft

Total Penetrations Area = 51 sq ft Total Roof Area Less Penetrations = 7,909 sq ft

Penetrations	1	2-3	4	5	6	7-12	13	14	
Area (sq ft)	0.9	1	1.5	2.2	2.3	4	5.2	12.2	
Perimeter (ft)	3.8	4	5	6	6	8	10	14

Any measured penetration smaller than 3.0x3.0 Feet may need field verification. Accuracy is not guaranteed. The total penetration area is not subtracted from the total roof area.
